Artifacts and Pitfall Errors Associated With Ultrasound-Guided Regional Anesthesia

Part II: A Pictorial Approach to Understanding and Avoidance

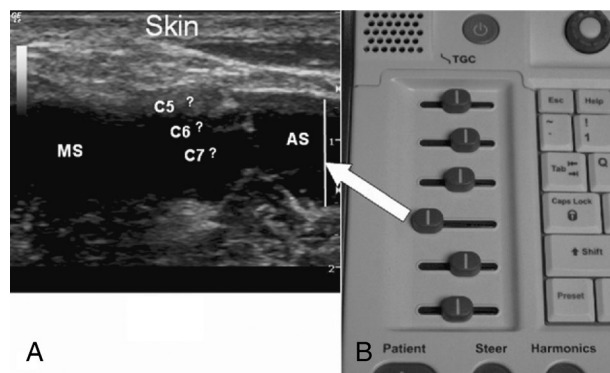
FIGURE 2. Incorrect use of the time gain compensation dials. A, The ultrasound image is the short axis view of the interscalene brachial plexus. The nerve roots are now apparently missing. The arrow points to the band of hypoechoic tissue created by the incorrect use of the fourth time compensation button. B, Note that the fourth time gain compensation dial is turned down, creating the band of undergain that eliminates the C5, C6, and C7 nerve roots. AS, anterior scalene muscle; MS, middle scalene muscle.

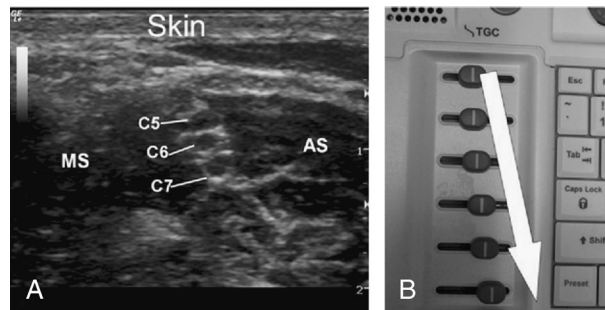
FIGURE 3. The correct time gain compensation (TGC) settings. A, The C5 through C7 nerve roots are now easily seen with the TGC settings. B, The diagonal arrow indicates the typical pattern for the TGC dials, with a progressive increase (right shift) for the deeper structures. AS, anterior scalene muscle; MS, middle scalene muscle.

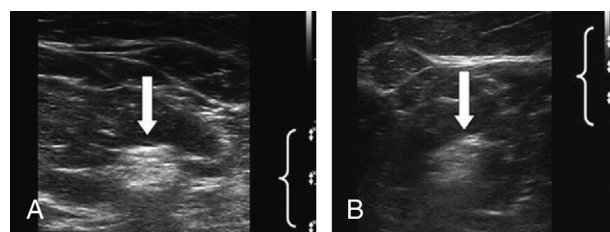
FIGURE 5. This is the short axis image of the sciatic nerve in the popliteal fossa showing the impact of the focus on image quality of a single structure. In (A), with the focus set correctly, the sciatic nerve is well defined. In (B), the focus is set incorrectly, thereby greatly degrading the image. The focus location is indicated by the { . With this particular system, there are multiple focal zones, explaining the three icons on the right side of the screen.

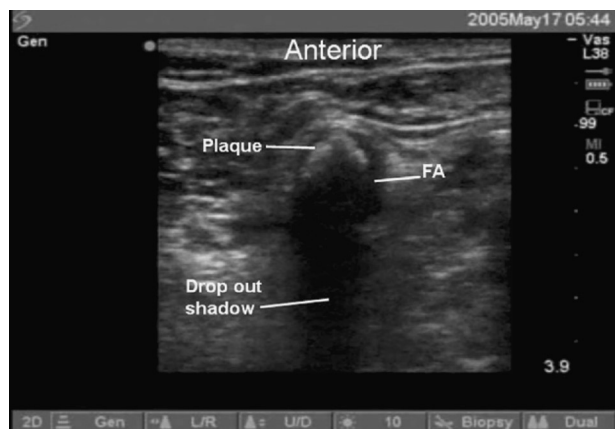
FIGURE 11. Ultrasound image of the femoral artery in short axis showing an atherosclerotic lesion. This pathology was identified during the performance of a femoral nerve block. Note the hyperechoic plaque and the acoustic shadow. Calcium deposits in the plaque act as strong specular reflectors. FA, femoral artery.

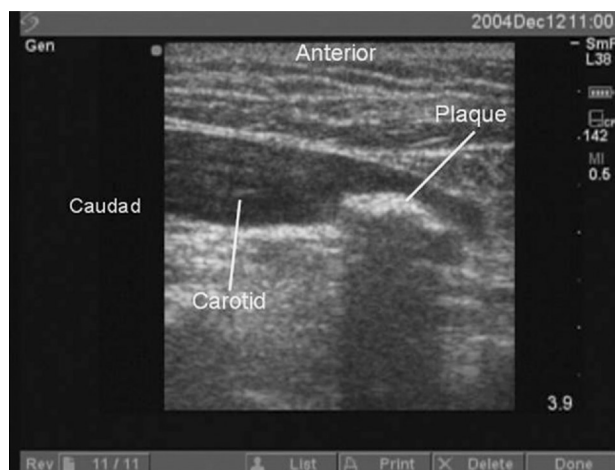
FIGURE 12. Ultrasound image of the carotid artery in long axis showing an atherosclerotic lesion. This pathology was identified during the performance of an interscalene catheter. Note the hyperechoic plaque and the characteristic acoustic shadow.

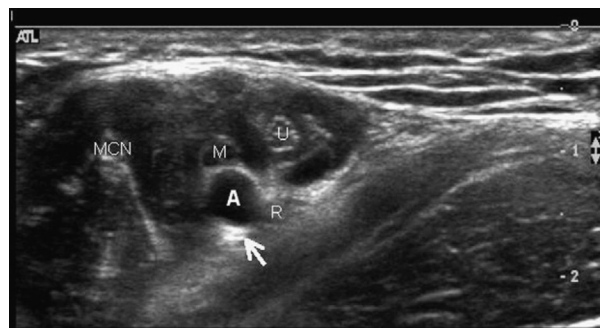
FIGURE 13. Ultrasound image of the structures in short axis as seen in the axillary fossa. Acoustic enhancement of the tissue immediately posterior to the blood vessel is indicated by the arrow. This hyperechoic area can easily be mistaken for the radial nerve (R) which is actually lying adjacent to the artery. A, axillary artery; M, median nerve; MCN, musculocutaneous nerve; U, ulnar nerve.

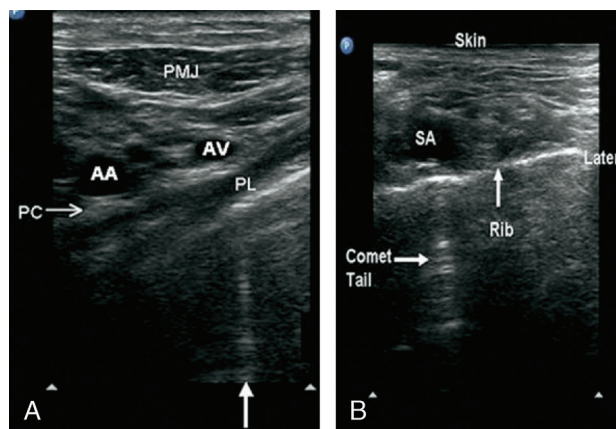
FIGURE 18. A, The comet sign visualized during preparation for an infraclavicular blockade. The streaks (“comets”) indicated by the arrows represent the convergence of multiple reverberations generated by the first rib imaged obliquely in the infraclavicular region. The unlabeled arrow indicates the comet tail. Slight repositioning of the probe to the sagittal plane causes these artifacts to disappear. B, Classic comet tail sign involving structures commonly seen during a supraclavicular block. AA, axillary artery; AV, axillary vein; PL, pleura; PMJ, pectoralis major; SA, subclavian artery.

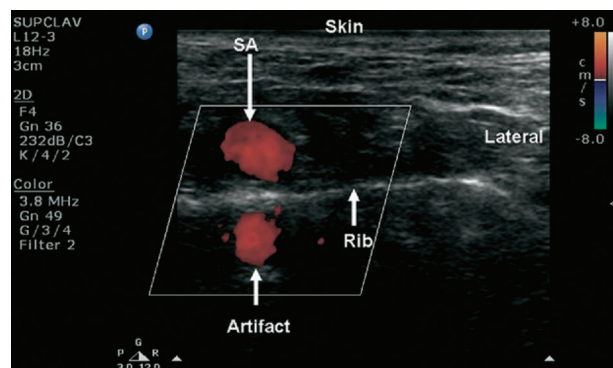
FIGURE 20. A reverberation artifact showing a duplication of the subclavian artery (SA) found during a supraclavicular block. The artifact exists for both the 2-dimensional image and the Doppler analysis. The artifact is the structure that is more posterior.

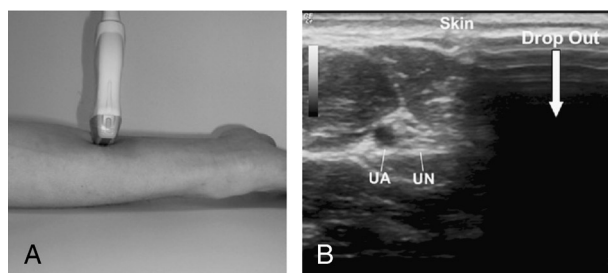
FIGURE 22. The incorrect position of the probe on the skin (A) can generate a large dropout shadow (B) which could complicate the performance of an ulnar nerve (UN) block in the mid forearm. UA, ulnar artery.

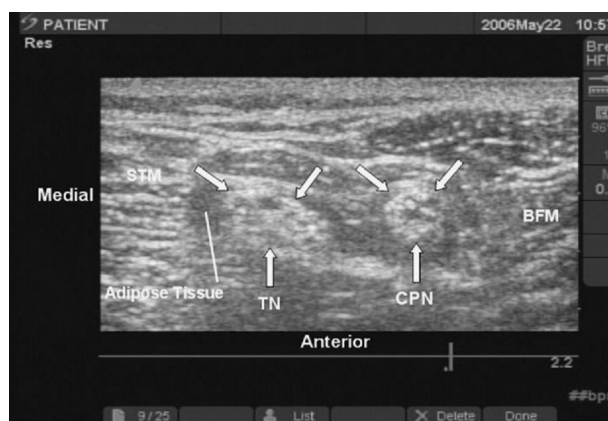
FIGURE 25. Short axis ultrasound images of the structures found in the popliteal fossa including the common peroneal (CPN) and the tibial (TN) nerves. Note the similarity of the nerves to the surrounding muscle. The only aspect of this image that supports the ability to identify the nerves is the small layer of adipose tissue that separates muscles from nerves. BFM, biceps femoris muscle; STM, semitendinosus muscle.

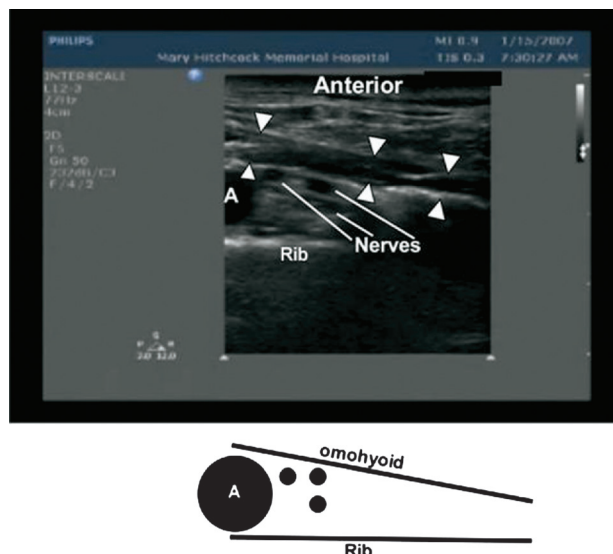
FIGURE 26. Short axis view of the brachial plexus and subclavian artery in the supraclavicular fossa. The triangles outline an anechoic structure resembling a large blood vessel imaged in long axis. This structure is actually the inferior belly of the omohyoid muscle. The divisions of the brachial plexus are sandwiched between the omohyoid muscle anteriorly and the first rib posteriorly, as indicated in the cartoon. A, subclavian artery.

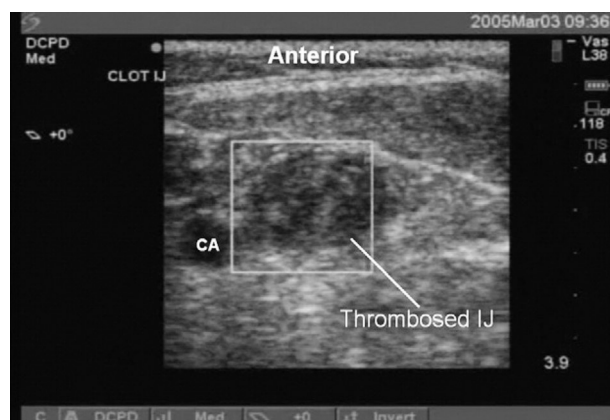
FIGURE 29. An occluded internal jugular vein found during the performance of an interscalene nerve block. Color Doppler flow demonstrated no flow and the vessel did not compress with light probe pressure. Note the hyperechoic thrombus found in the normally anechoic lumen. CA, carotid artery.

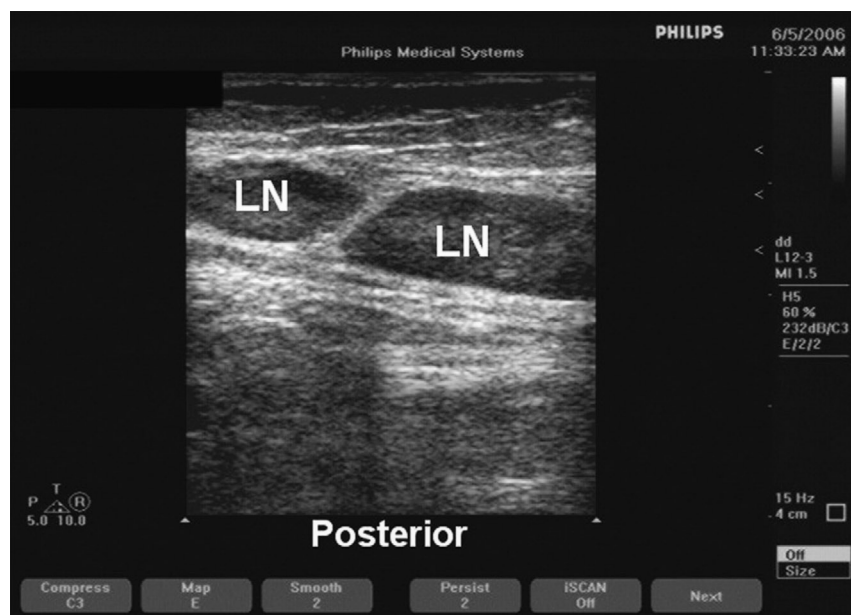
with well developed muscles and little adipose tissue. The sciatic nerve of an athlete as imaged proximally in the popliteal fossa is shown elsewhere in Figure 3 of Part I.³ The difficulty in distinguishing the sciatic nerve from the surrounding muscle is due to the paucity of surrounding adipose tissue.

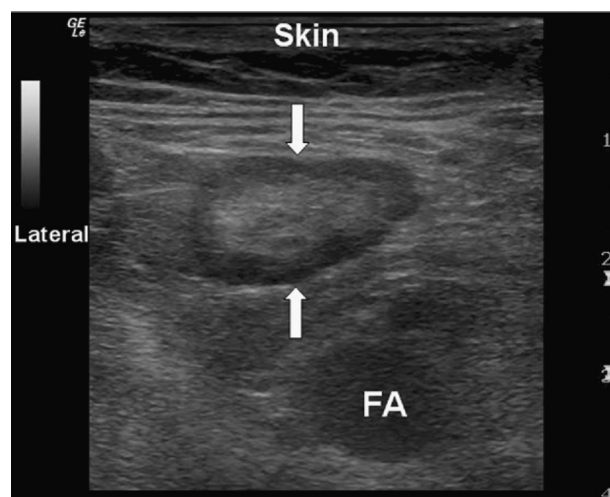
FIGURE 31. Ultrasound appearance of an inguinal lymph node discovered during the performance of a continuous femoral nerve catheter. We originally believed this structure to be an occluded saphenous vein. However, patency of the saphenous vein was later confirmed. The anechoic outer ring of the lymph node (indicated by the arrows) represents perinodal edema, whereas the more echogenic interior represents the soft tissue aspects of the node. FA, femoral artery.

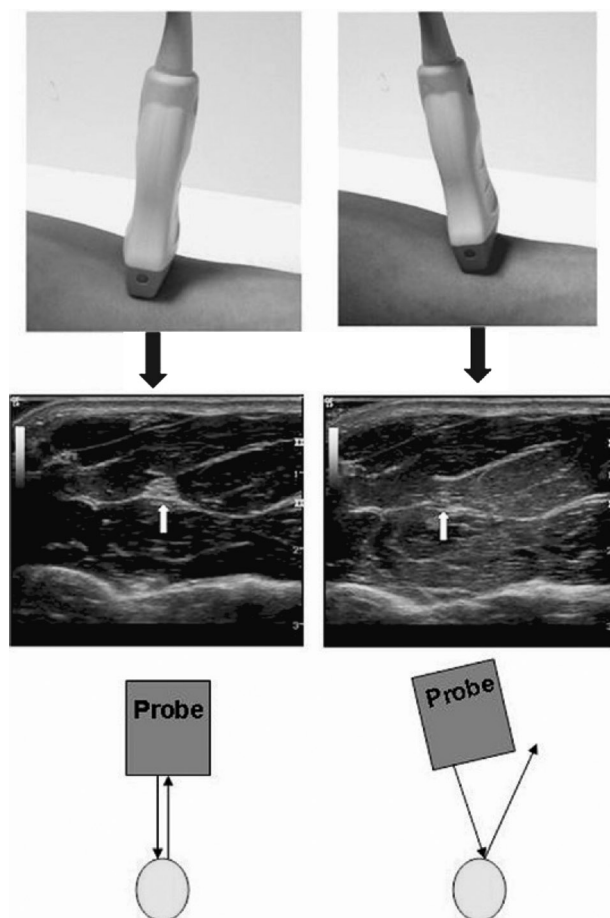
FIGURE 33. Short axis view of the ulnar nerve in the mid forearm. The angle of incidence between the ultrasound beam and the nerve is important for optimal imaging. Subtle angulations can result in dramatic variations in image quality. The right hand side of the Figure depicts a situation where a subtle tilting motion of the probe results in degradation of the image, presumably from a reduction in effective reflection and an increase in refraction. The left hand side of the figure represents the ideal situation with optimal imaging. The white arrow indicates the ulnar nerve.
